Manhole Inspection Summary

Manhole # S37W__011MH

Insp Date: **3/5/09 11:43 AM**

Location Address: **1705 byrd st**

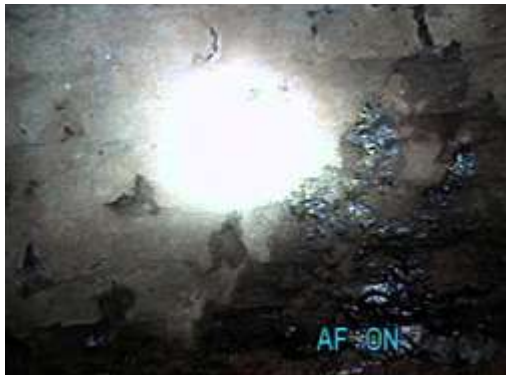
Defect 4

Infiltration: ☐ None ☐ Joint ☐ Cracks ☐ Mortar ☐ Roots ☒ **Wall**

barrel infiltration

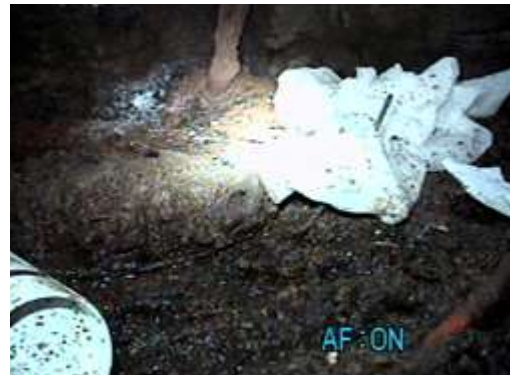
Defect 3

Condition: ☐ Sound ☐ Cracked ☐ Root Intrusion ☐ Deteriorated ☐ Leaks ☒ **Debris**

channel debris

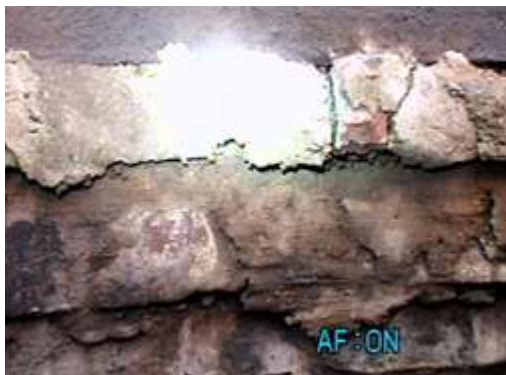
Defect 2

Condition: ☐ Sound ☒ **Cracked** ☐ Root Intrusion ☒ **Loose Brick** ☒ **Deteriorated**

chimney cracked and deteriorated, frame adj

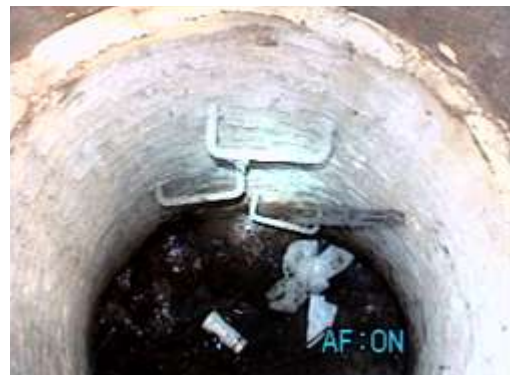
Defect 1

Count: **3** Missing: **0** ☒ **Corroded**

cor. steps
